CLEAN-COAL TECHNOLOGY BY-PRODUCTS USED IN A HIGHWAY
EMBANKMENT STABILIZATION DEMONSTRATION PROJECT

A Thesis

Presented in Partial Fulfillment of the Requirements
for the Degree Master of Sciences in the
Graduate School of The Ohio State University

The Ohio State University
1994

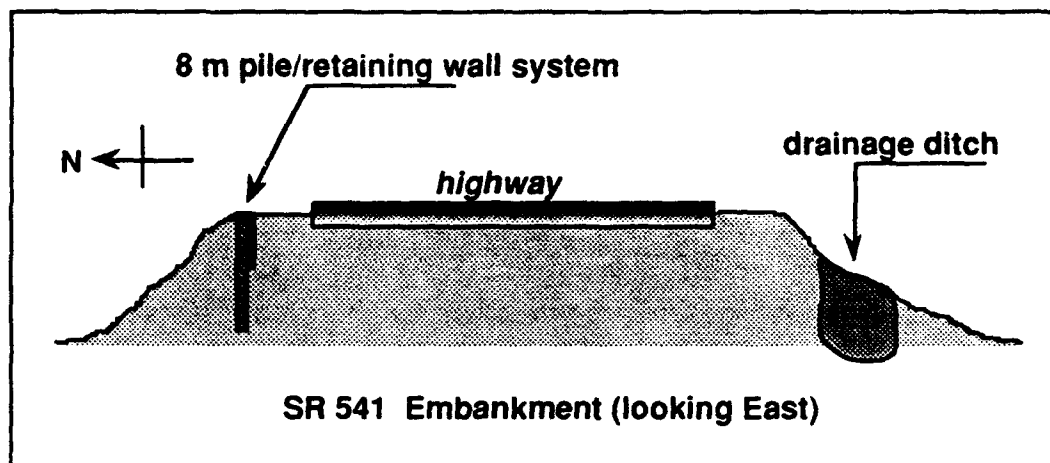
Figure 2.2. SR 541, 1986 ODOT Repair.

There is very little repair history for this section of roadway for the first 20 years after construction was completed. In 1985, road surface settlement was noticed around Station 55+00. The road settlement became progressively worse and was accompanied by some indications of a rotational slide. Reportedly, the base of the embankment was covered with small traverse ridges and there was evidence of soil upheaval. In 1986, an ODOT repair team attempted to correct the problem and prevent any further deterioration by digging a 4 meter deep trench at the top of the slope for a distance of approximately 25 meters and driving a series of 8 meter piles. Next, sections of guardrail were attached to the piles that effectively created

In the summer of 1989, realizing that the pile-supported retaining wall had failed to prevent the road surface from settling, a more comprehensive repair was ordered. The eventual uncovering of the piles revealed how dramatic the embankment movement was. The base of the piles, which was approximately 8 meters below grade, had moved approximately 2 meters down slope. This equates to a rotation angle for the piles of almost 20 degrees. It is safe to assume that the tops of the piles remained relatively stable as they were found in their original drive locations. Additionally, the tops of the piles had guardrails attached to them to act as a retaining wall, which greatly reduced any horizontal movement. The piles were removed and the embankment material was excavated to a depth of 13 meters below the road surface. Two drains were installed near the top of the embankment to intercept the water which had been detected during excavation. The excavated material was replaced in controlled lifts and the slope was brought back to its original condition (2:1 slope). These drains are still active, particularly after periods of heavy rainfall or snow melt (Newhart, 1994).

a 25 meter long, 4 meter wide retaining wall. The trench was then backfilled and the highway surface repaired. Another trench was excavated on the south side of the roadway and a drain was installed to intercept surface and subsurface flow associated with the adjacent hillside. Figure 2.2 depicts that repair effort. The repair seemed to work and nothing further was done to this section of highway for the next three years.

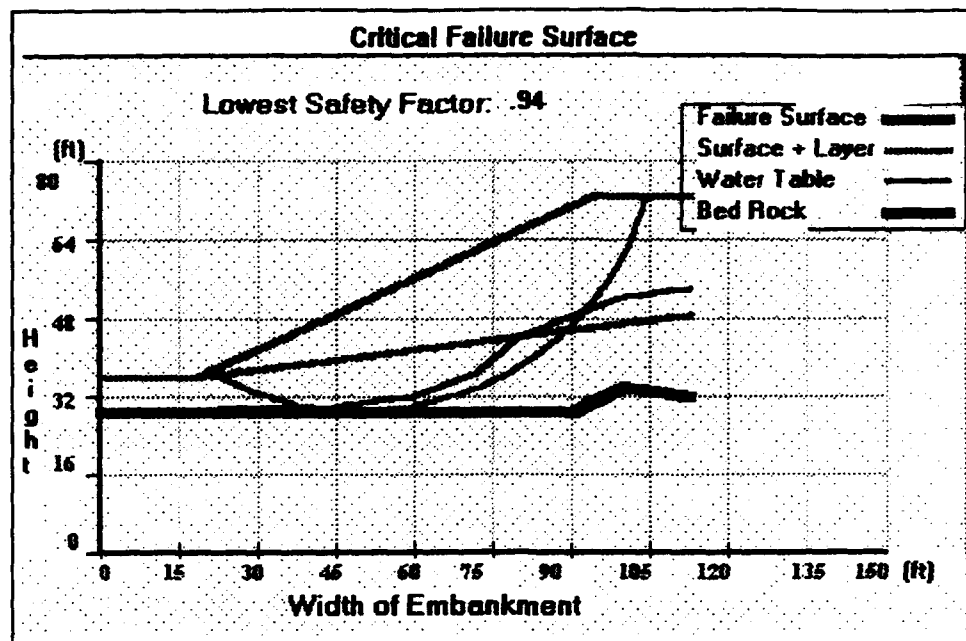
Figure 3.2 depicts the original embankment and the most critical failure surface. It shows a rotational failure starting approximately 2 meters from the edge of the highway and terminating near the toe of the slope. The failure surface is a circular arc that passes through the embankment material and natural soil, tangent to the underlying bedrock. The calculated factor of safety associated with this slope is approximately 0.95.

Figure 3.2. SR 541 Embankment, Original Profile, Critical Slip Plane.

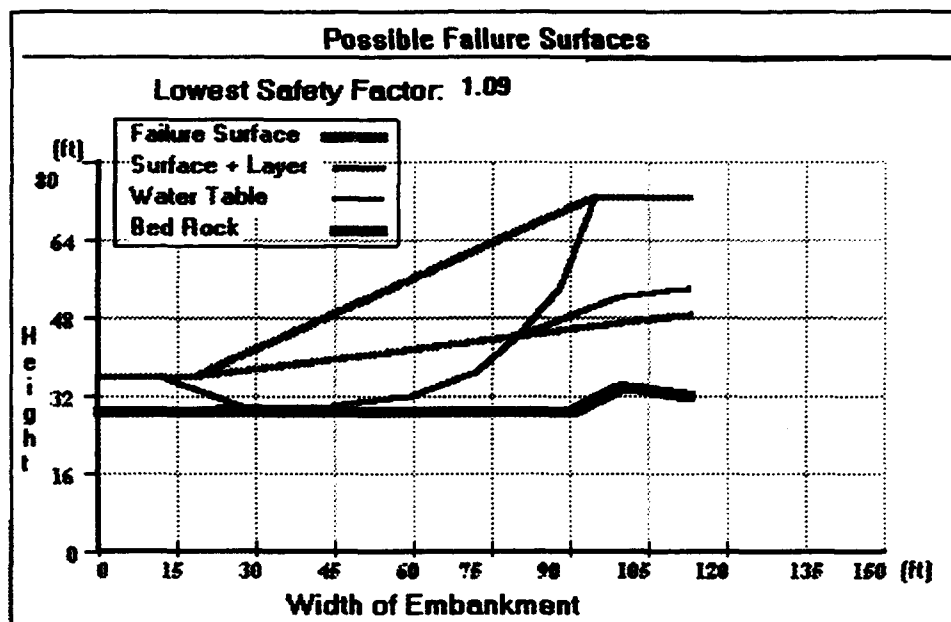
the failure plane and the elevation of the water table. Given the variable nature of soil and the possible alternate locations for the water table, the author feels the results match well. It may be inferred that the two failure surfaces are nearly identical, as is the difference in the calculated factors of safety (0.95 v. 1.1).

Figure 3.3. SR 541 Embankment, Original Profile, Actual Slip Plane.
